## **SERVICEORDRE – 2009-2**

**SERVICE BULLETIN SPSB005**  
**JH101-3 (HIP RING MLW) AND JH101-4 (4 RING MLW) RING DAMAGE**  
**INSPECTION**

**SERVICE BULLETIN #** SPSB005

**SUBJECT:** HIP RING AND 4 RING MAIN LIFT WEB INSPECTIONS

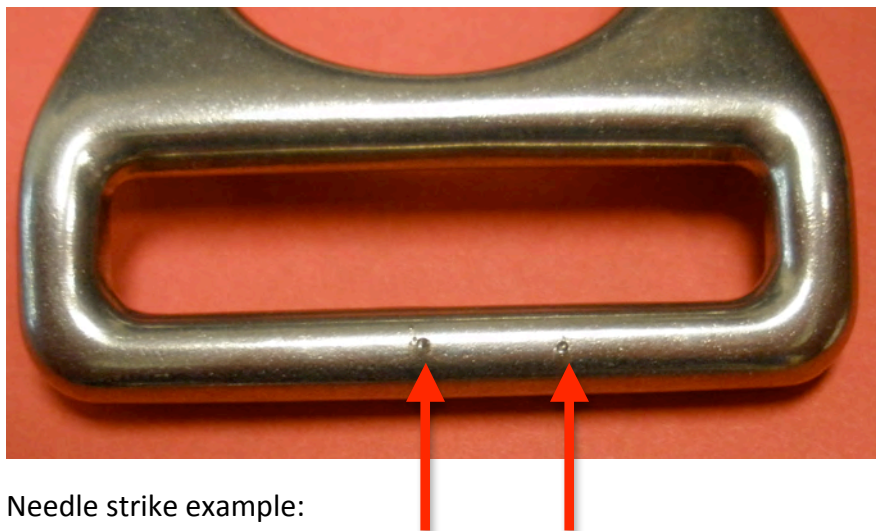
It has been brought to our attention that the hip ring on JH101-3 (Hip Ring Only) and JH101-4, (4-Ring) main lift webs, may have been struck by the needle used for installing the 5 cord harness stitching. This needle strike on the hip ring may cause damage to the Type 12 buffer, 5 cord stitching and possibly the Type 7 webbing. As a precaution, a mandatory inspection of the hip rings is required for all systems with a date of manufacture between **September 2008 and December 2008**.

The picture below is an example of a needle strike on an SR8 hip ring.

Needle strike example:

1. If damage is found or suspected, the harness/container will need to be sent to Sun Path Products, Inc. for repair. Please ship to the following address and include a completed Hip Ring Damage Repair Form found at the end of this document:

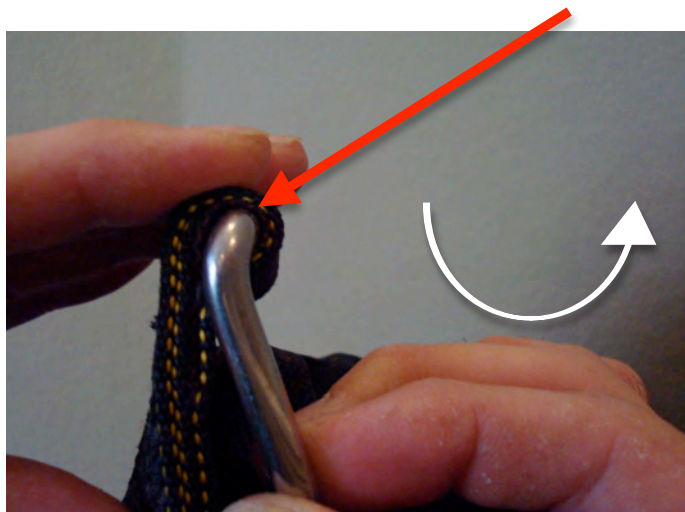
WHILE ROTATING, FEEL HERE FOR NEEDLE STRIKE.

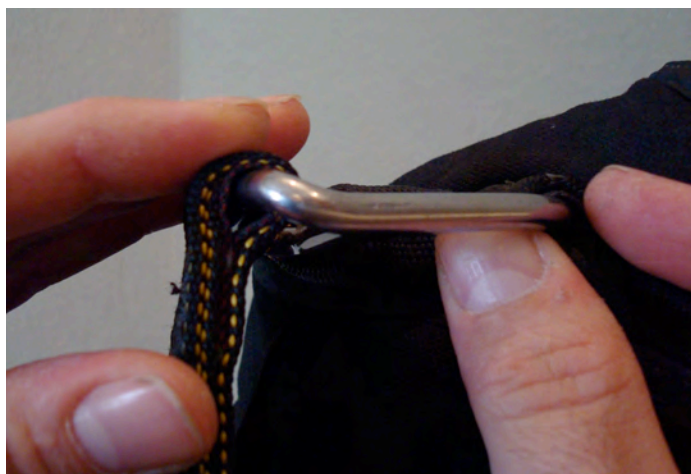
ROTATE UPWARD

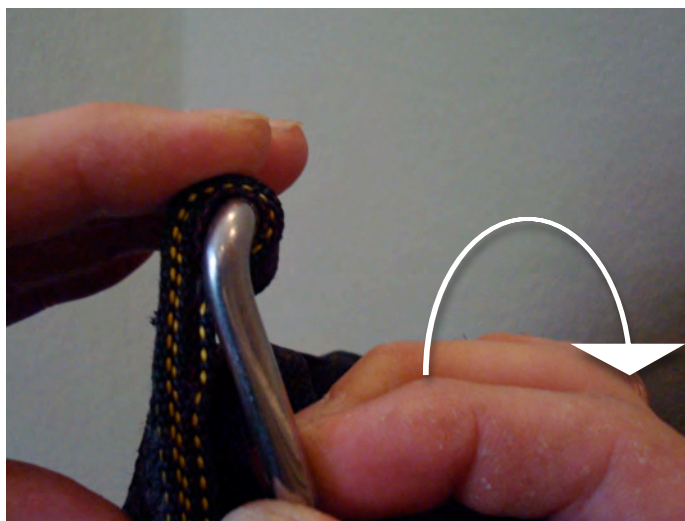
ROTATE DOWNWARD
