Serviceordre – Materiell

SERVICEORDRE – 2012-1

SERVICE BULLETIN #20111109

SUBJECT: Inspection of the top diagonal attachment point on all Sigma Sport Tandem Systems.

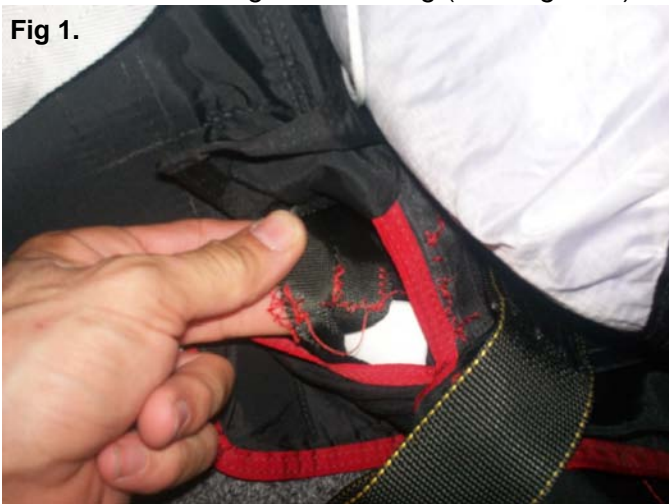
Fig 1.

BACKGROUND: During an inspection and repack, a rigger noticed the left side zigzag stitching that holds the diagonals to the top of the reserve container had completely failed and was no longer securing the container to the diagonal webbing (See Fig 1 - 2).

If the diagonals are damaged and in need of repair, riggers in the field are now authorized and requested to make this zigzag repair of the damaged area as usual, then make an additional third pass (3 total passes) in the "E" shape stitch pattern. It is the intent of the new third pass to duplicate this structural integrity on stitch patterns with a minimal stitch count.

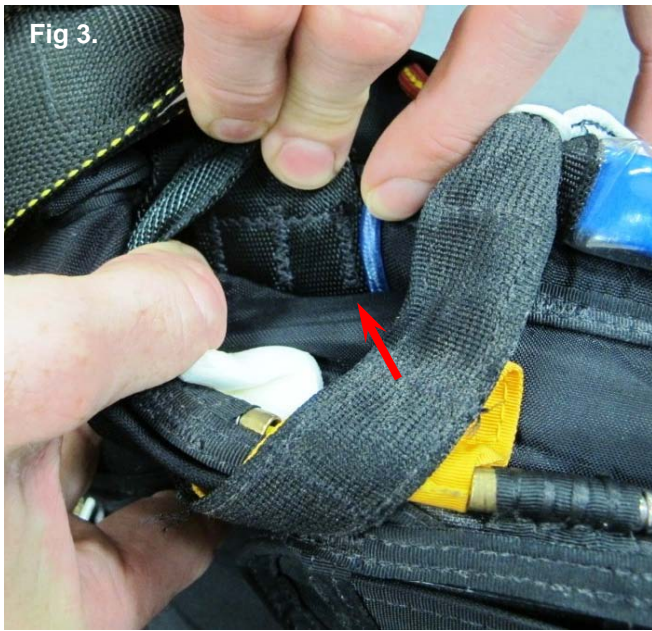
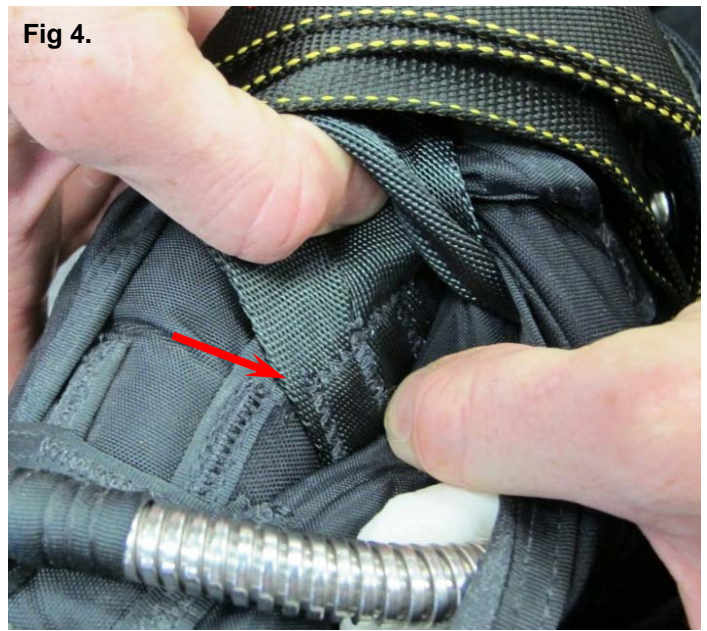
SERVICE BULLETIN: All Sigma Sport Tandem Systems are to be inspected for broken stitching at this diagonals attachment point. This can easily be done on packed rigs by simply opening the reserve pin cover and riser covers, then work your thumb up under the diagonal to expose the zigzag stitching as shown in Fig 3 (*right side*) and Fig 4 for (*left side*). Consult a rigger if you are unsure or have any questions. This inspection should take no longer than 1-2 minutes.

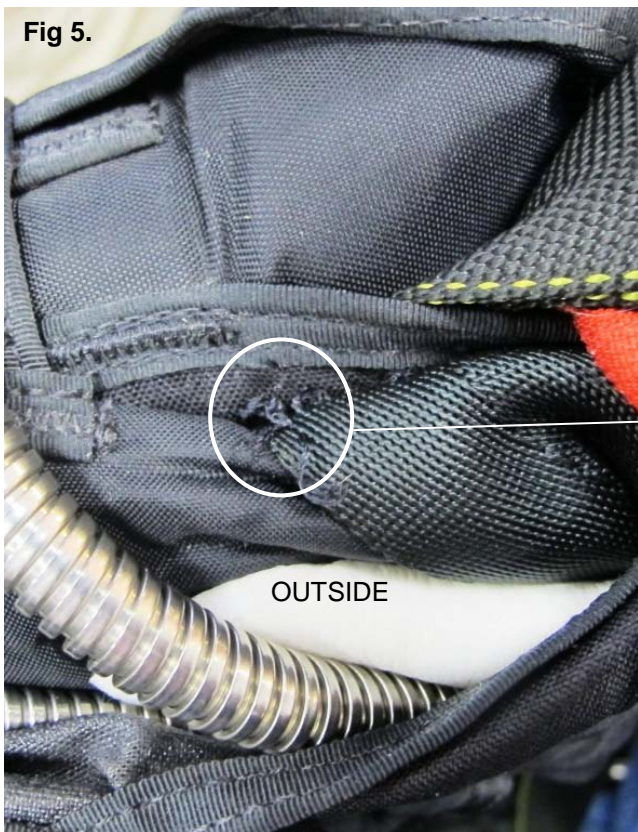
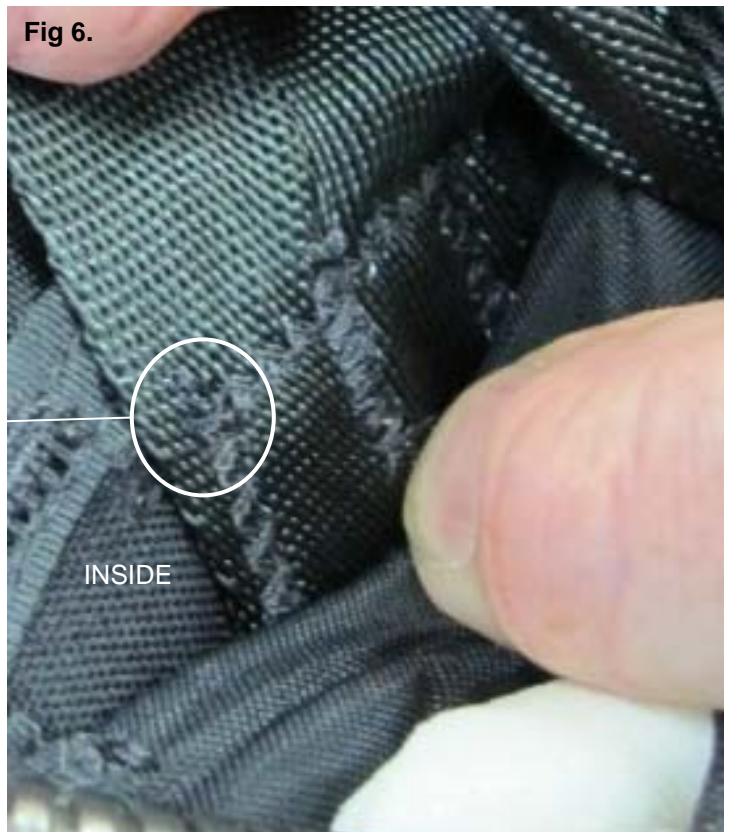
NOTE: If only very minor stitch damage is found (*up to 20%*) at this stitch pattern such as Fig 5-6, the repair can wait until its next repack.

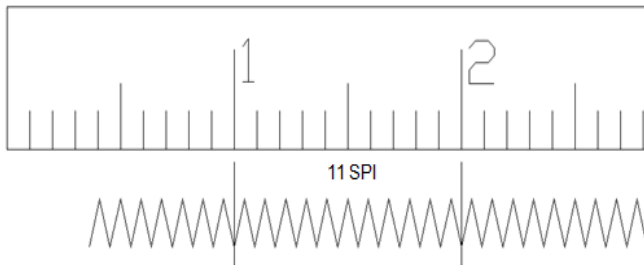
Fig 9. Counting zigzag stitches per Inch (SPI) as per Pointers Manual

NOTE: The correct stitch count for this diagonal attachment point is 10- 11 SPI (See Fig 9).
