SERVICEORDRE – 2013-4

SERVICE BULLETIN SPSB009

SUBJECT: SUPPLIER/VENDOR RECALL OF PS70104 HOUSINGS (METAL FLEX HOISING INC)

STATUS: MANDATORY INSPECTION AND REPLACEMENT OF RECALLED HOUSINGS

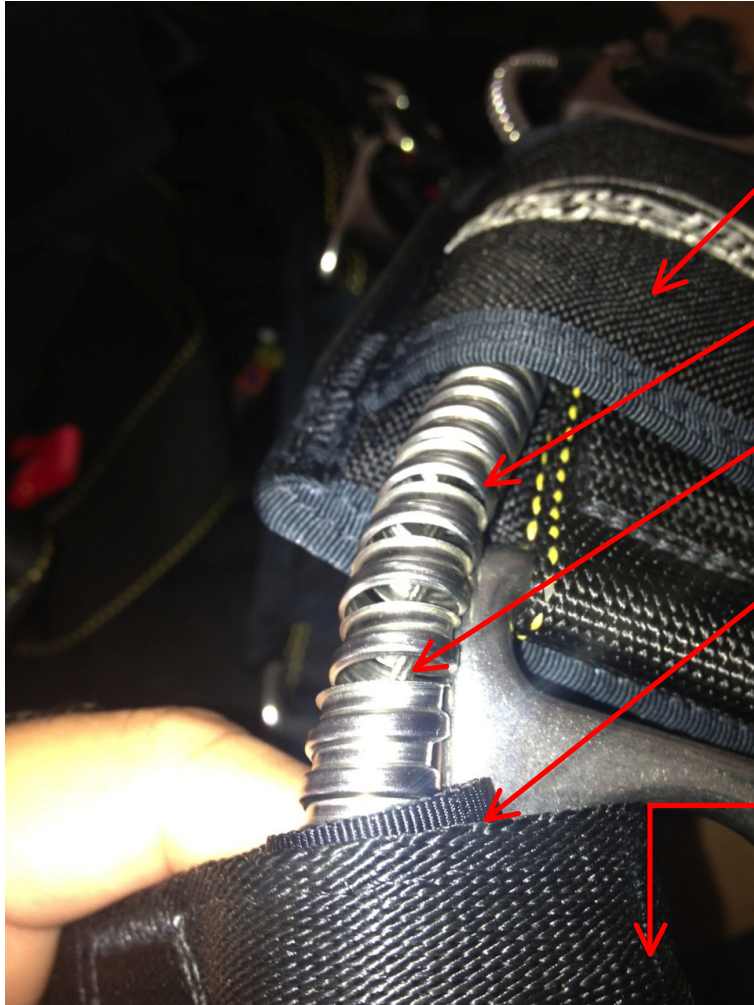
WEARERS LEFT SIDE:

SEPERATED HOUSING (FOR REFERENCE)

If the serial number is listed in the above table, inspect the available exposed reserve ripcord housing. Locate the lower end of the housing, which is clamped to the Main Lift Web, just above the reserve ripcord pocket. Inspect the exposed length of housing from the clamp upwards; ensure that the coil has not separated/unraveled. Be sure to inspect the section that is routed through the chest strap.

A. HOUSING FOUND TO BE INTACT (GOOD): The rig may continue to be jumped with periodic monitoring until the next repack cycle or earlier elective replacement. However this housing must be replaced at the next repack cycle. See <http://www.sunpath.com/support/HousingReplacement.pdf> for instructions for your rigger to complete the replacement of the housing.

B. HOUSING FOUND TO BE SEPERATED/UNRAVELLED (BAD): The housing must be replaced before the next jump by a certificated senior or master parachute rigger (or foreign equal) or the manufacturer. See <http://www.sunpath.com/support/HousingReplacement.pdf> for instructions for your rigger to complete the replacement of the housing or instructions to send your system back to the manufacturer.
