Rapport nr. 15/2020

Dato:	29.07.2020, kl 17:40
Type hendelse:	Forsert landing før baneenden
Fly:	LS8-18, LN-GCG
Sted:	ENOP
Pilot:	EASA SPL
Vær:	7 kt, 180 grader. Temperatur 18 °C og QNH 995 hPa. Spredte skyer og god sikt. Skybas 6000 fot. Mindre lokal bygeaktivitet.
Antall ombord:	1
Personskader:	Kutt i tommel
Skader på fly:	Ja

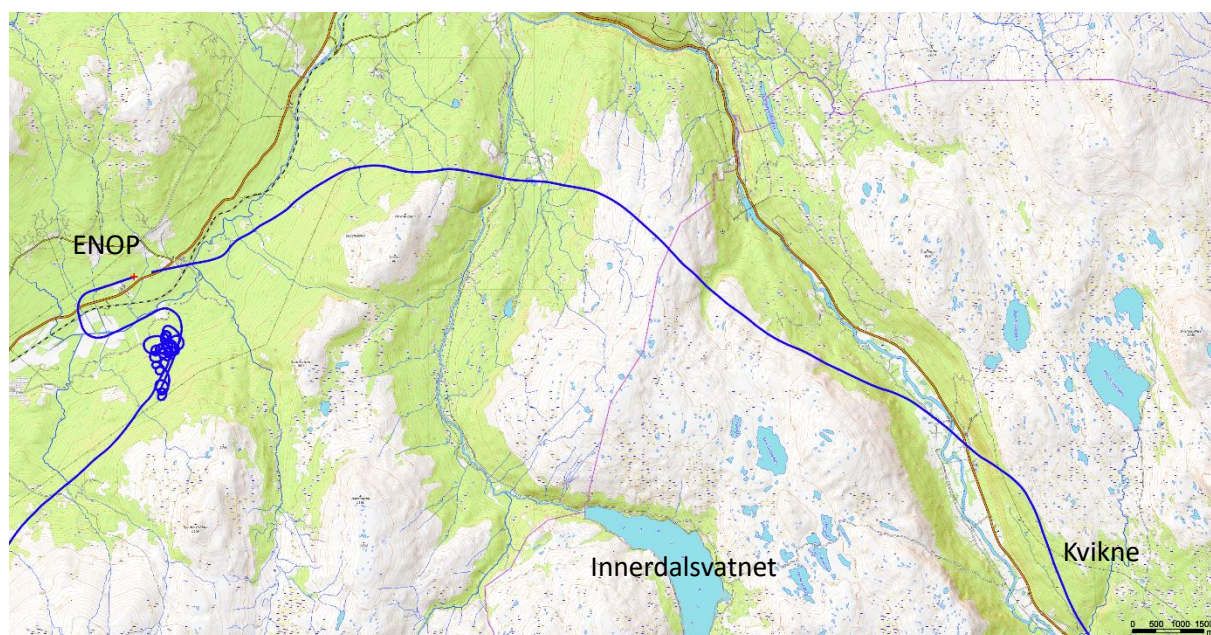
Fig 1: Track fra flightcomputer. Takeoff og start på turen mot vest, og turens siste del med retur fra øst.

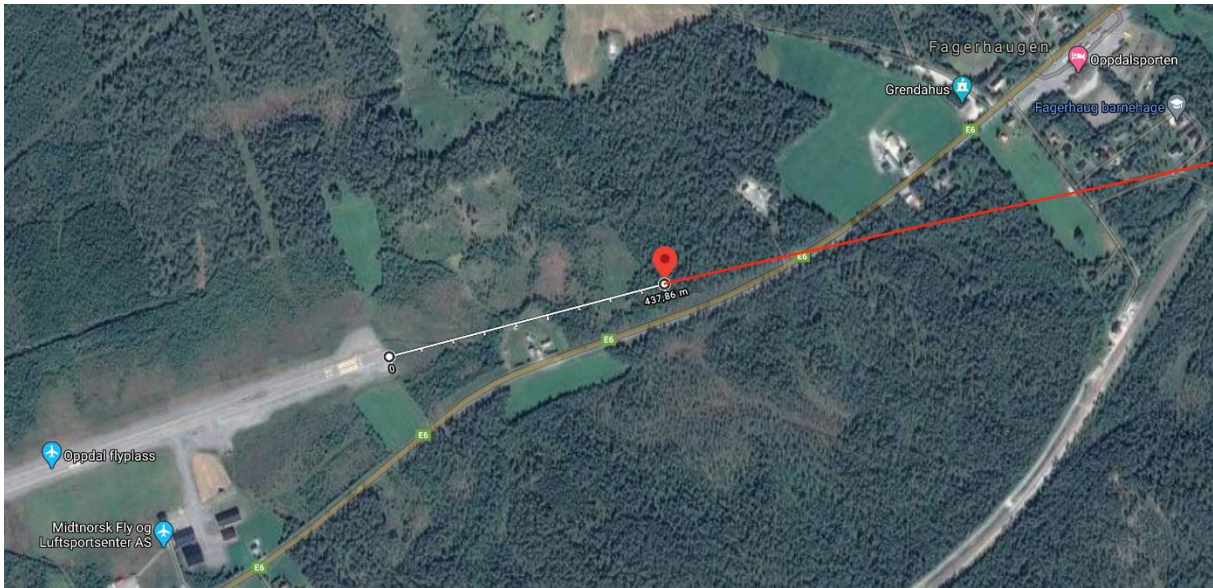
Hendelsen skjedde under organisert seilflyging på ENOP. Dette var fartøysjefens andre flyging denne dagen. Turen var en strekkur i områdene vest, og sør-øst for flyplassen. Fartøysjefen krysser over fjellparti fra Kvikne i retning ENOP, og finner ikke sitt valgte utelandingsjorde ved ankomst til dalen der flyplassen ligger. Fartøysjefen flyr da videre mot flyplassen og nødlander til slutt i skogen ca 450 meter fra terskel baneende 25.

Fig 2: Utsnitt fra Google Maps, anmerket havaristed (rød markør), avstand (hvit), samt siste del av flightherecorder track (rød strek)

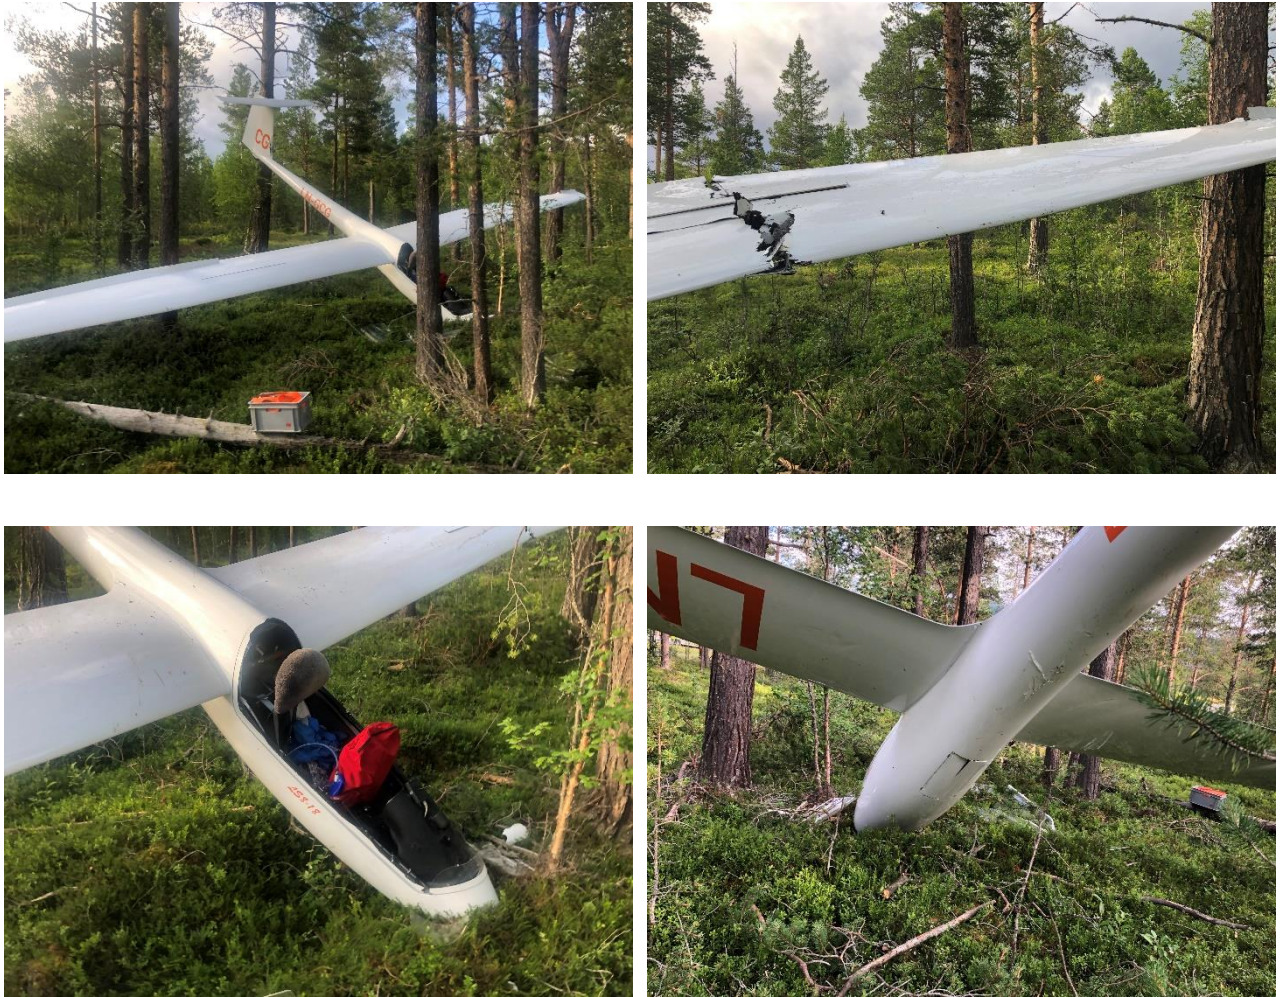
Flyet fikk store materielle skader i havariet.

Fig 3: Skader på flyet

Det ble ikke avdekket feil på flyet som kunne ha vært der før hendelsen, og som kunne ha medvirket til hendelsen.
