# **SERVICE BULLETIN**

**Owner's Service Bulletin – OSB 29 Issue 1**

**Applicability – Ikarus C42 all models**

**Inspection of main fuselage tube for cracking around cut-outs**

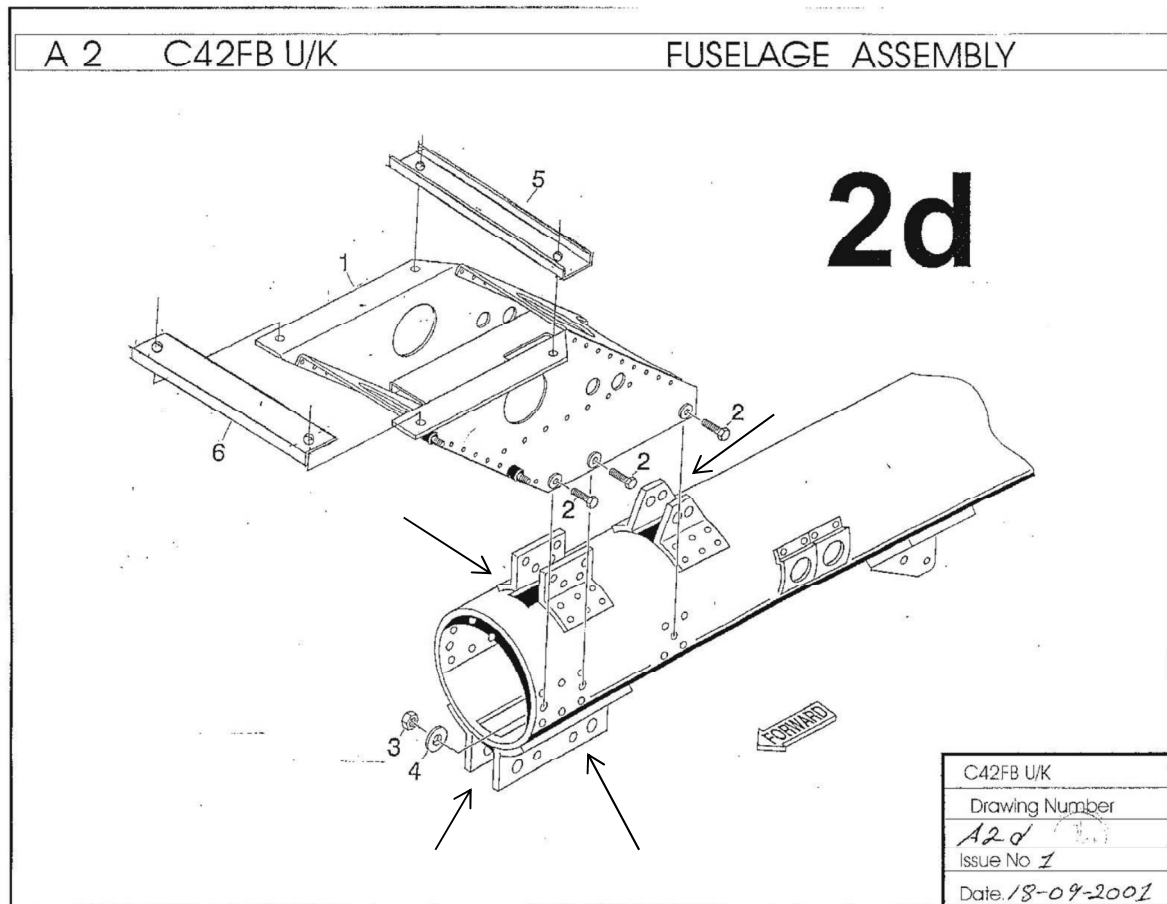
Nose-leg and A-strut cut-outs at front of main fuselage tube in vicinity of engine mount.

- Notes: 1. the stainless steel brackets securing the A-strut to the top side of the fuselage tube (the rearmost brackets shown above) were lengthened compared to those shown in the diagram above in around 2007, see the photo further below.
2. the holes for the A-strut attachment (the rearmost set of holes, one in the top of the main fuselage tube, one in the bottom) were eliminated entirely around 2015.

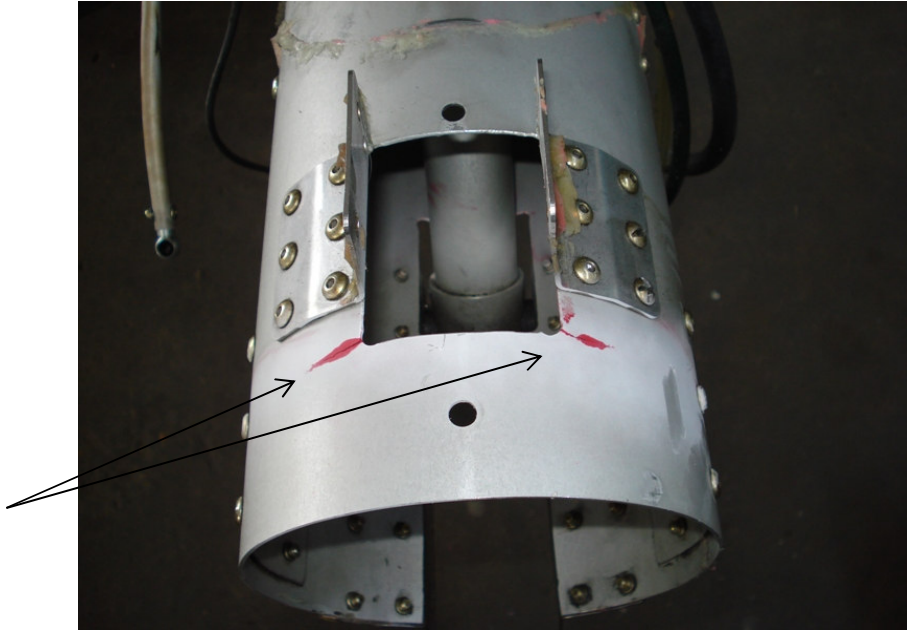
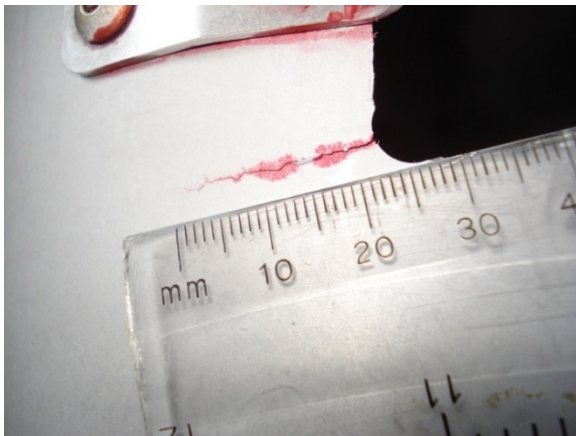
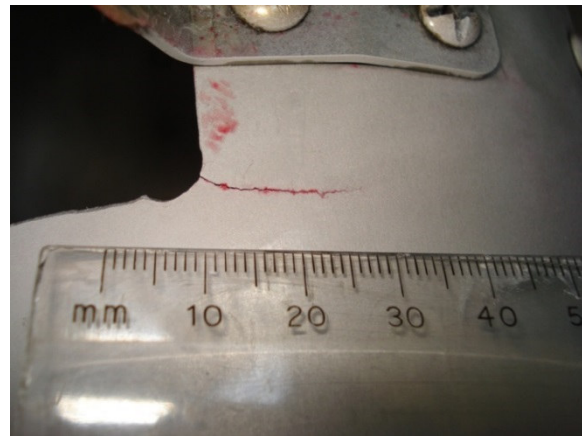
High hours examples of early C42 aircraft have exhibited cracks emanating from the corners of the cut-outs in the main fuselage tube where the nose-leg and A-strut are fitted.

Example cracks on upper surface of main fuselage tube at corners around nose-leg cut-out.

The perimeter of the cut-outs in the main fuselage tube where the nose-leg and A-strut pass through the main fuselage tube must be visually inspected for cracking, with particular attention paid to the corners.

If any cracking is found please contact Red Aviation. An approved repair scheme involving the fitment of an inner sleeve to the forward end of the main fuselage tube is available.

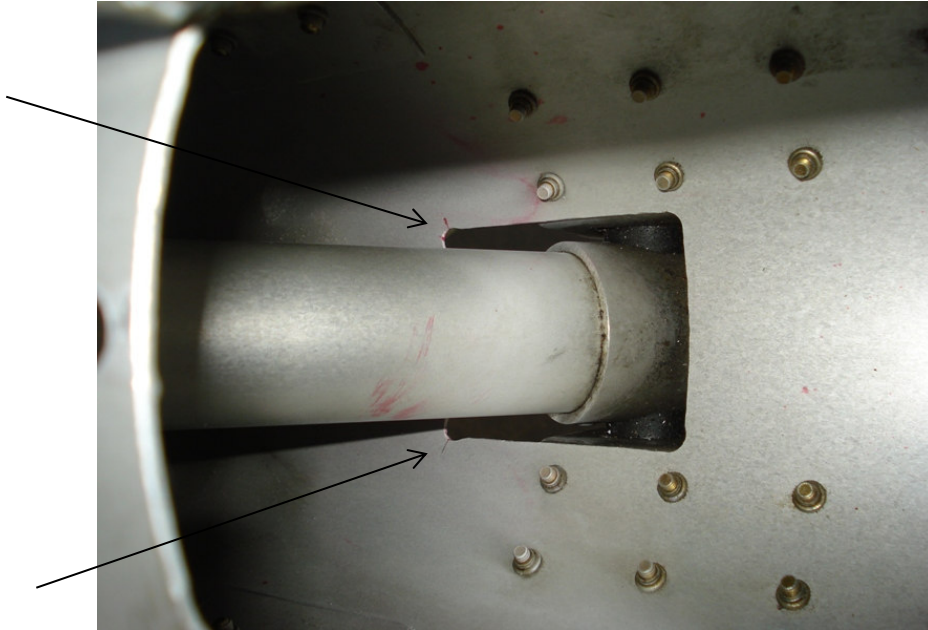
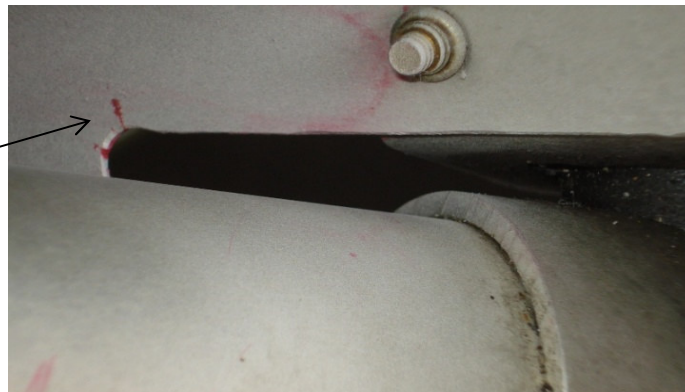
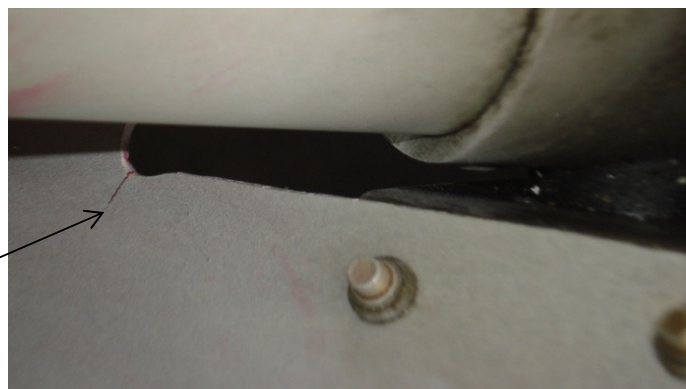
Example cracks on lower surface of main fuselage tube at corners around A-strut cut-out.

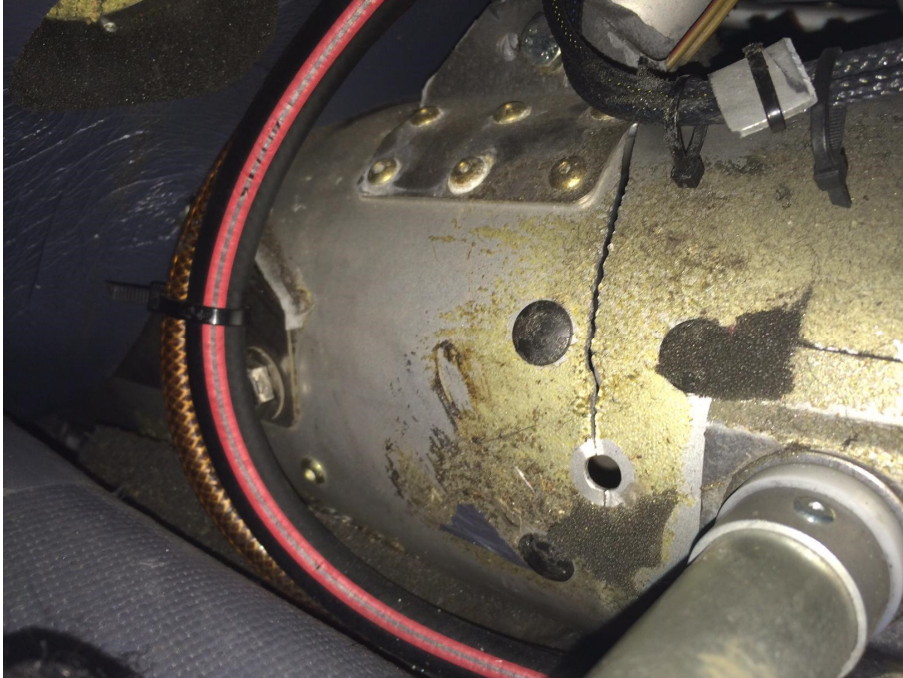
Example of significant crack allowed to propagate on 4500hr aircraft. This crack was hidden by the firewall sound-deadening foam. Ensure that it is removed for inspection.

Remove the area of sound-deadening foam on the cockpit side of the firewall which hinders inspection of the A-strut cut-out just forward of the rudder pedals on the top of the main fuselage tube. This is the area which concealed the significant crack shown in the example photographs above.

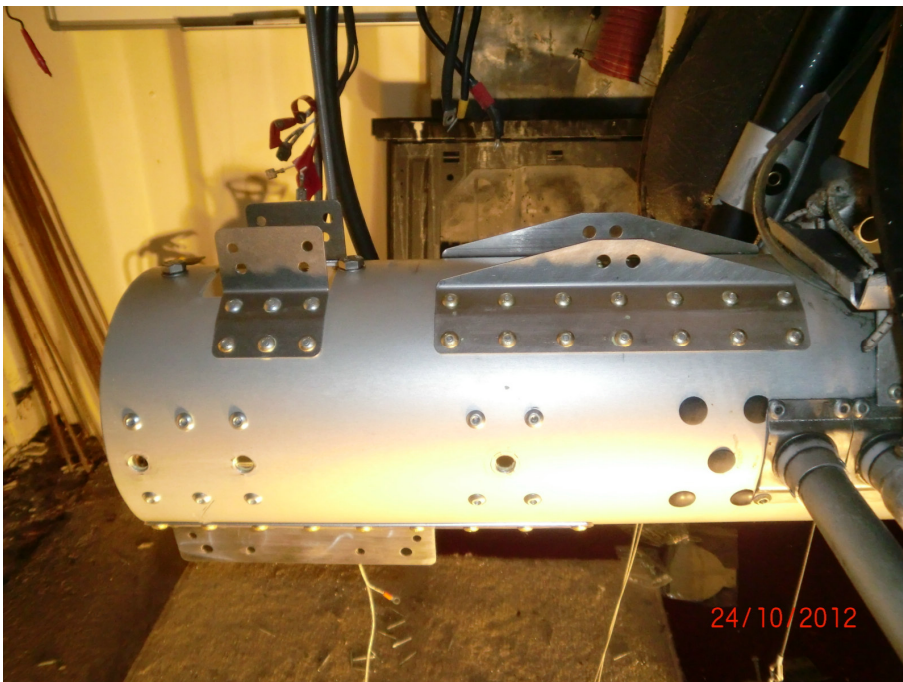
Lengthened A-strut top attachment brackets as found on aircraft from around 2007.
