## **SAFETY NOTE HANGGLIDER HARNESS**

### **TENAX DHV 03-0111-00**

**Subject** Hangglider harness Tenax DHV 03-0111-00

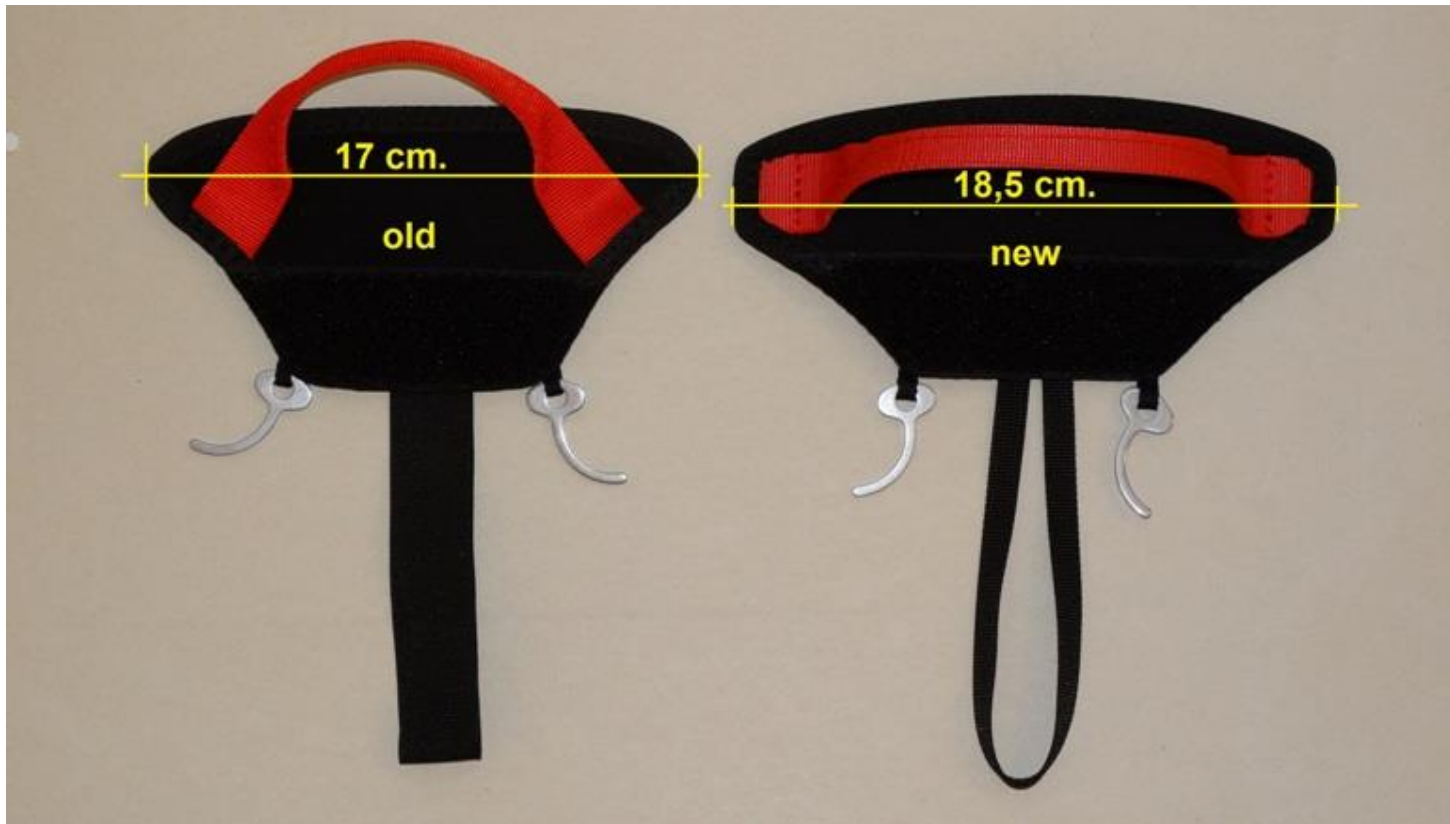
In some single cases, the dimension of the reserve parachute handle is a bit too small for fixation at the harness. The handle is then not safely fixed, because the side ends can slip out on their own accord. Woody Valley recommends all owners of the Tenax 3 harness, to check the handle and fixation at the harness. The side ends of the handle should stick safely in the fixation. If the handle is too loose in the fixation, Woody Valley recommends affected owners replacing the handle. Woody Valley offers a proper handle for free.

All Tenax 3 harnesses, which have been manufactured since the middle of 2012, are equipped with the new handle. To be sure you can compare your handle to the attached photo:

Concerned owners are asked to contact the manufacturer or the national importer.
