SERVICEORDRE – 2011-4

HENVISNING:	Icarus Servicebulletine # 2011001, 27 juli 2011
FORMÅL:	Bytte av C1 line på NEOS
STATUS:	Obligatorisk
IDENTIFIKASJON:	Alle NEOS skjermes P/N 317524-XXX med serienr lavere enn 24112612 og alle størrelser.
BAKGRUNN:	Det har vært et økende antall klager på sporadiske harde åpninger. Icarus har gjennomført lange og mange tester før de fant ut av problemet og fikk utviklet et tiltak mot dette. (For detaljert beskrivelse se side 1 i produsentens SO)
SERVICE:	C1 linen skal byttes iht den vedlagte tekniske manualen fra produsenten.
UTFØRELSE:	<p>Før neste hopp. Byttet av C1 lina utføres av MK/MR og det skal foretas kontroll av at C1 lina er festet ytterst på quick- eller softlinken (se tech ordre fig 14). Etter byttet skal vedlagte kontrollmal (side 3 i produsentens SO) fylles ut og sendes til icarusorders.eu@icaruscanopies.aero Skjermens advarsels "etikett" skal merkes med C1 når utført (se Tech ordre fig 17) Når alt dette er utført, påføres riggens kontrollkort SO 2011-4 byttet C1line ok.</p> <p>Modifiseringskitet kan bestilles gjennom Icarusforhandler. Ved bestilling skal skjermstørrelse og serienummer oppgis. Icarus opplyser at det er omkring to ukers

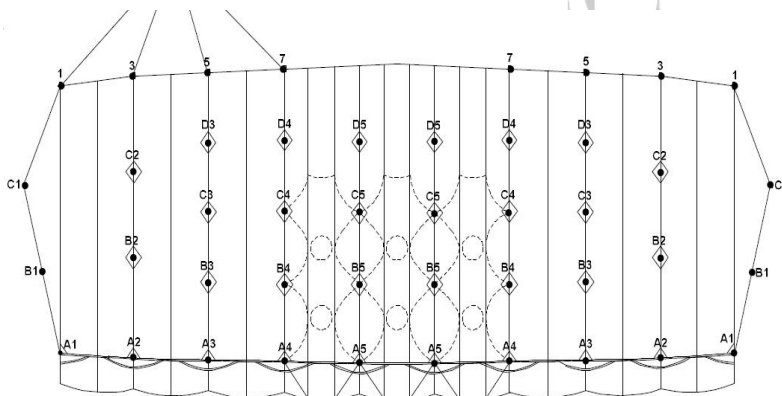
Fig. 1. Distribution of the lines in the Neos canopy.

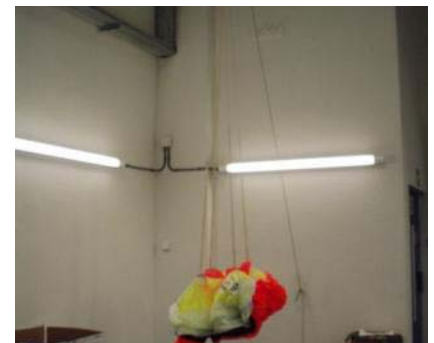
Fig. 2. Hang the canopy with the suspension lines at the same height. If the parachute is assembled on risers, make sure that they are the same length.

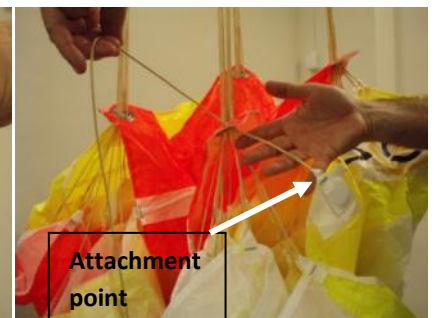
Fig. 5. Follow the C1 line to the attachment point.

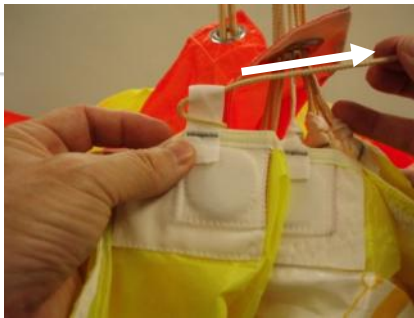
Fig. 9. Apply tension on the C1 line to fix the knot.

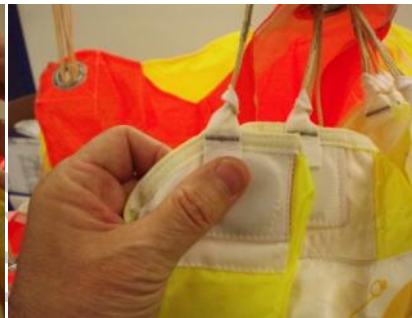
Fig. 10. Check the knot orientation line to fix the knot.

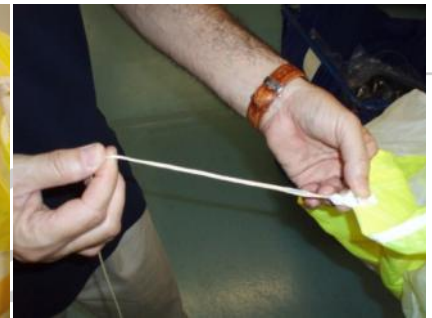
Fig. 11. Make sure there is no twist along the C1 line.

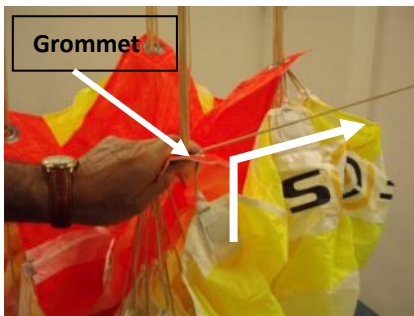
Fig. 12. Pass the C1 line through the corresponding slider grommet.

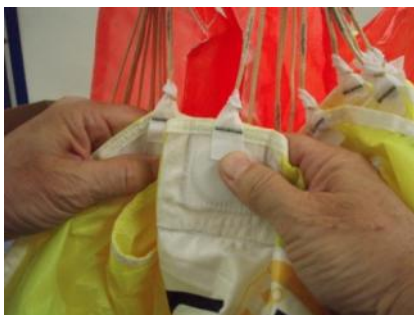
Fig. 15. Take the C1 and B1 attachments and check that they are at the same height.

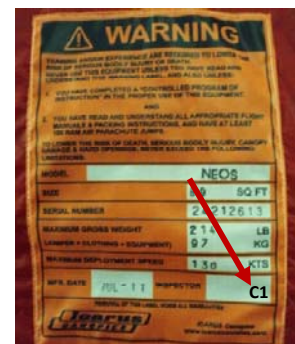
Fig. 17. When the modification is completed, mark "C1" with permanent marker in the inspector box on the warning label.
