FRONT CONTAINER RESCUE HANDLE RECALL

IMPORTANT SAFETY NOTICE

Lite, Lite PPG and Cockpit Rescue Containers

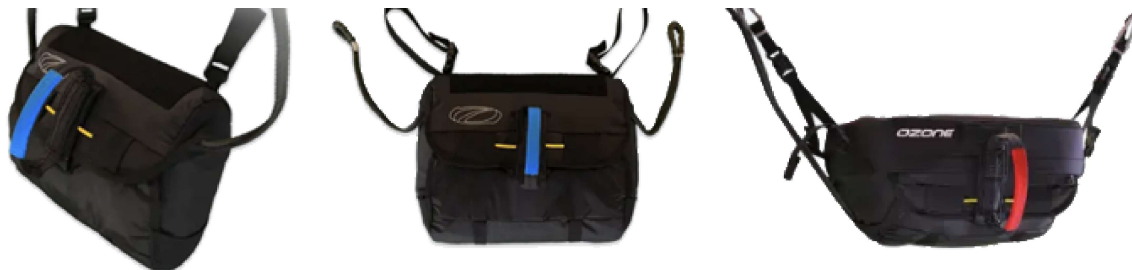
We have detected a manufacturing defect over one rescue handle delivered together with a reserve container. The following reserve containers produced between Jan 1st, 2021 and June 16th, 2025 might be concerned:

Lite Rescue Container

Lite Rescue Container PPG

Cockpit Rescue Container

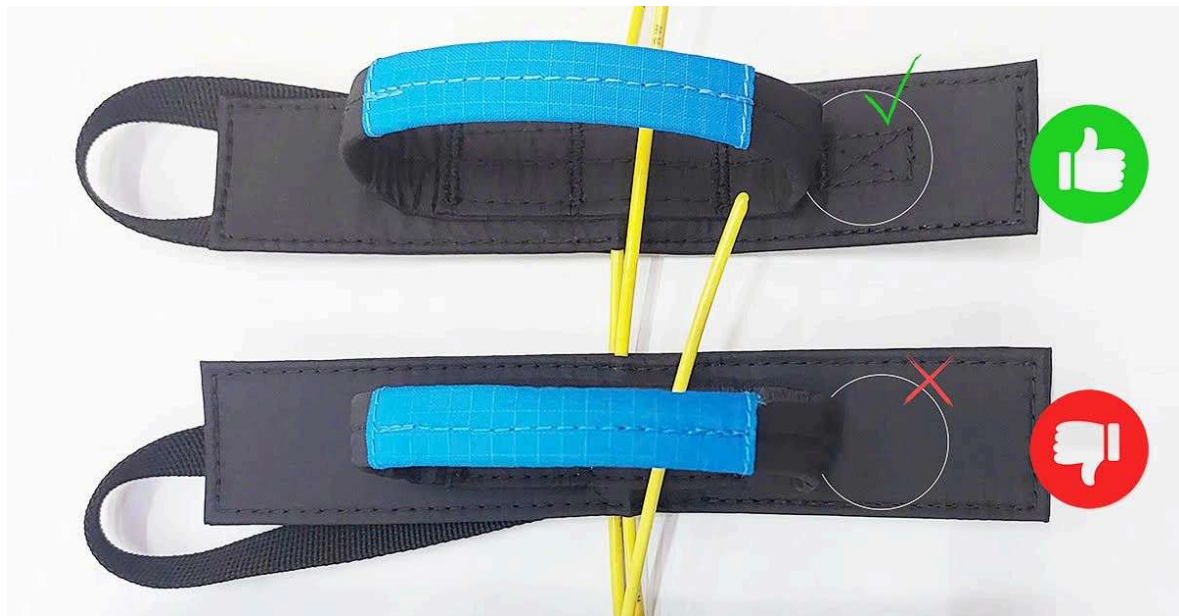
The default affects the connection from the handle to container lanyard. This defect could result in the handle connection breaking before the reserve is fully deployed.

The replacement handles have a visible box-stitch pattern, as shown below.

As a precaution, we ask that all container handles produced during this period be immediately taken out of use. The handles must be replaced before next use.

Please contact the retailer from whom you purchased your container to receive a free replacement handle after returning your handle, which will be destroyed.
