## Servicebulletin 2026-01

## Technical Bulletin TB220526 Aerodyne ICON H/C reserve top flap modification

<b>DATE OF ISSUE</b>	:	<b>22 May 2026</b>
<b>SUBJECT</b>	:	Reserve Container Static Ground Test Observations and Optional Modification
<b>STATUS</b>	:	<b>Advisory:</b> or relevant skydive association requirement
<b>COMPLIANCE</b>	:	Compliance with this bulletin is optional and not required for continued airworthiness.
<b>IDENTIFICATION</b>	:	All ICON Containers

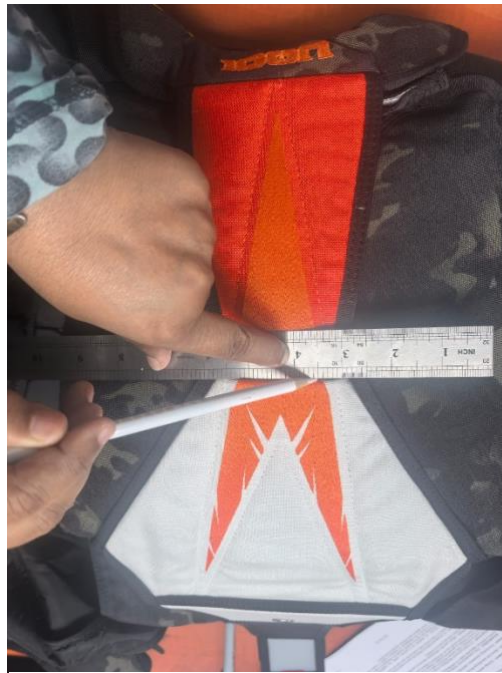
Figure 1.2

Mark the Position of the Reserve Pin Flap as shown in figure 1.2.

Note, this distance may vary when the Harness and Container is worn

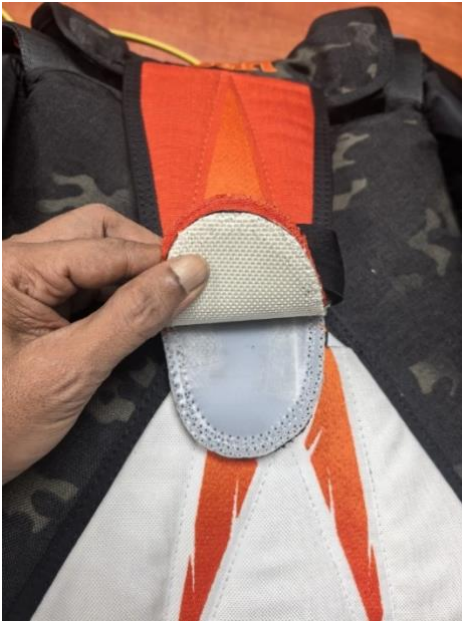
Identify the plastic panel as shown in Figure 2.4

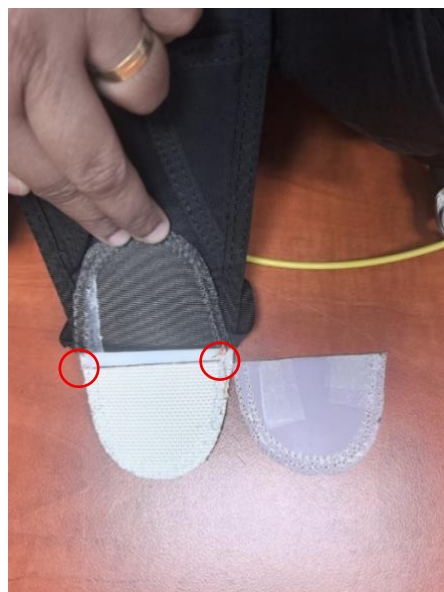
Figure 2.7 Plastic cut

After cutting the plastic as in figures 2.6 and 2.7, cut a very small diagonal at the remaining edge of the plastic to remove the potentially sharp point.
